NATIONAL TRANSPORTATION SAFETY BOARD
Office of Aviation Safety
Washington, D.C. 20594

HELICOPTER SPECIALIST'S FACTUAL REPORT

NTSB No: CEN15LA156

Operator: Era Helicopters LLC
Aircraft: AgustaWestland AW119 MK II, Registration N802SM
Location: Houma, Louisiana
Date: February 20, 2015
Time: 0750 central standard time

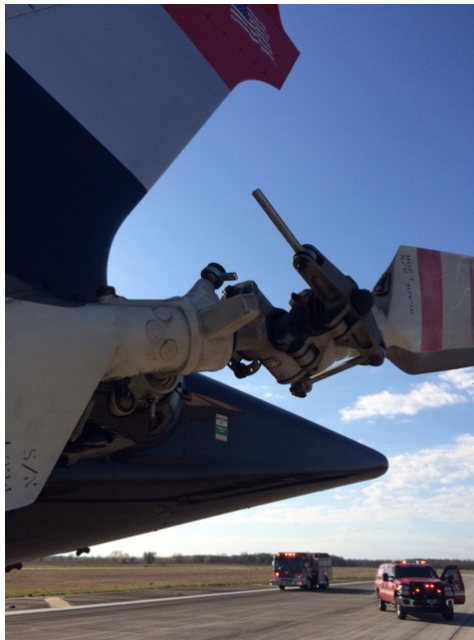
Both the fractured and opposing tail rotor PCLs removed from N802SM were identified as P/N 109-130-05-117. The fractured PCL was identified as serial number (S/N) MO.3000; the opposing tail rotor PCL was identified as S/N MO.2781. **Photo 1** was provided by Era Helicopters documenting the condition of the tail rotor PCLs as found during the post-landing

Photo 1. The fractured and opposing tail rotor PCLs during post-landing inspection. (Photo courtesy of Era Helicopters)

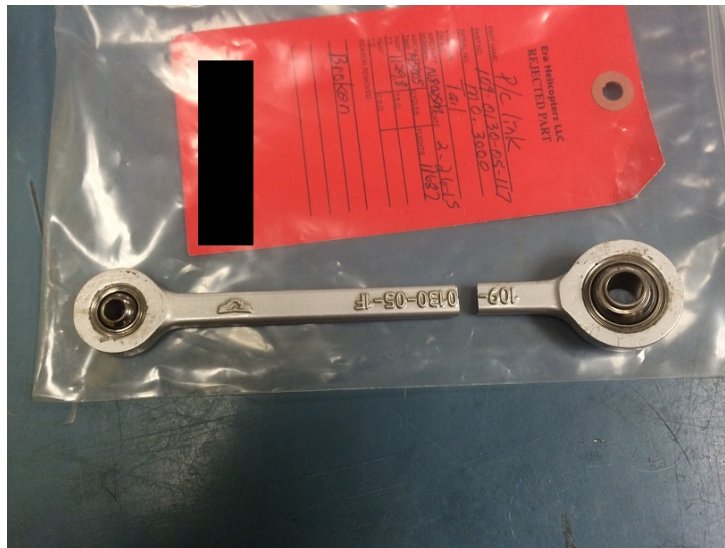
inspection performed after the run-on landing at HUM. **Photo 2** was provided by Era Helicopters documenting PCL S/N MO.3000 after its removal from N802SM.

Photo 2. PCL S/N MO.3000 after removal from N802SM. (Photo courtesy of Era Helicopters)

PCL S/N MO.3000 and MO.2781 were examined by the NTSB Materials Laboratory in Washington, District of Columbia. The fracture surface of PCL S/N MO.3000 exhibited evidence of fatigue originated at a raised dash that was part of the PCL P/N marking on the PCL. The materials laboratory characterized fatigue cracking across 60% to 70% of the fracture cross section. For additional details on the materials laboratory examination, see Materials Lab Factual Report No. 15-084 in the docket for this investigation.

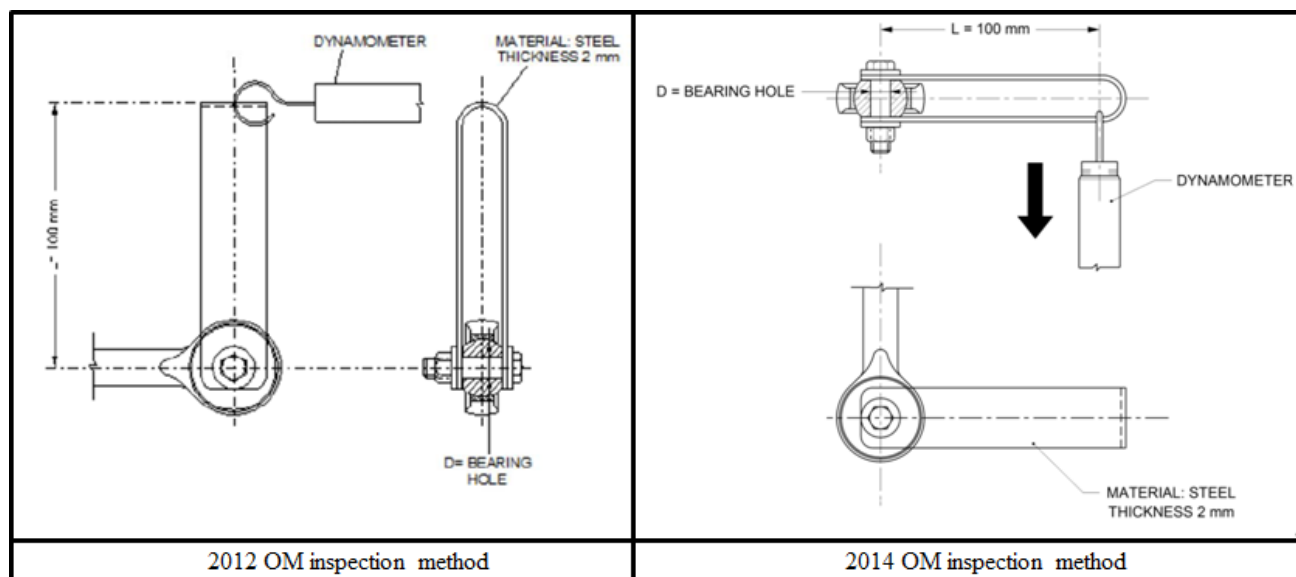
The tail rotor PCL bearing rotational torque requirement was found to be the same within Revision 6 of the AgustaWestland AW119 MK II maintenance manual (MM), Section 64-31. However, the method of inspecting PCL bearing rotational torque was found to be different between an earlier version of the AW119 MK II OM, dated November 25, 2012, and a more recent version of the OM, dated November 10, 2014. The 2012 version of the OM required rotational torque inspection by rotating the inspection tool, a 100 millimeter (mm) lever arm, about the axis of the bearing bolthole, while the 2014 version of the OM required the inspection tool to be rotated away from the axis of the bearing bolthole (**Figure 1**). The bearing replacement procedures between the 2012 and 2014 versions of the OM remained the same. AgustaWestland identified the 2012 version of the OM contained the correct bearing rotational torque inspection method. PHP identified they had used the 2014 version of the bearing rotational torque inspection method.

Figure 1. The bearing rotational torque inspection methods. (Image courtesy of AgustaWestland)

Based on the findings of this investigation, AgustaWestland had corrected the figure within the tail rotor PCL bearing replacement procedures to display the correct method of inspecting spherical bearing rotational torque. Additionally, the PCL bearing replacement procedures were removed from the MM and are now found only within the OM.
